Appendix F

Historical Shoreline Data and Trends

Coastal Resources, Processes, and Vulnerabilities

October 6, 2023

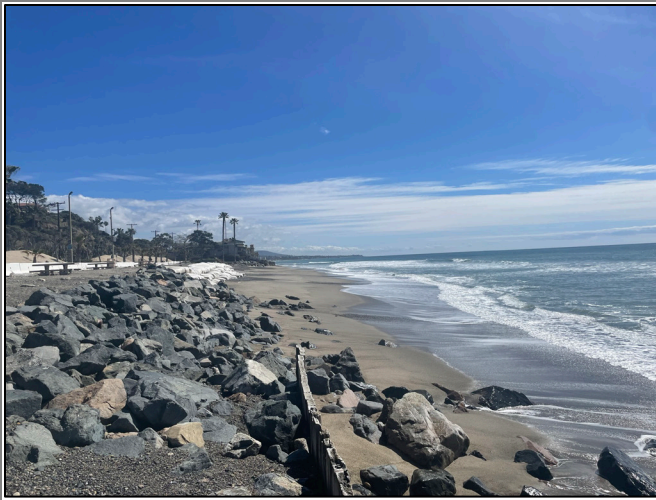
Capistrano Beach Park riprap and sandbags
(Anchor QEA, March 6, 2023)

Along Capistrano Beach Park, the beach profile has eroded back towards the parking lot. The riprap and sandbags help to mitigate the beach erosion, as shown in Figure 7. Since 1985, a landward retreat of the shoreline has been observed; by 2019 the shoreline reached the rock revetment fronting the parking lot (OC Parks 2021b). Significant beach nourishment occurred in the 1960s and 1970s (Table3). Sand has been placed as a byproduct of harbor maintenance dredging conducted sporadically by the County (OC Parks 2021b). Nearshore placement at Capistrano Beach Park occurred in 2000, 2009, and 2016.

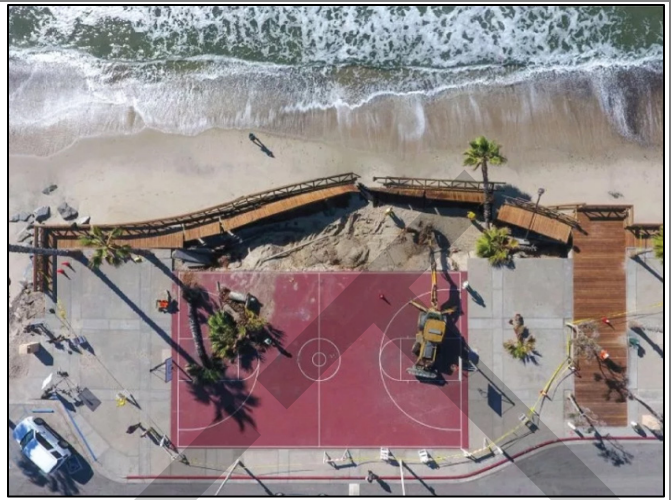
Basketball court and boardwalk damaged in 2018 and removed
(Jeff Gritchen, Orange County Register/SCNG, December 4, 2018)

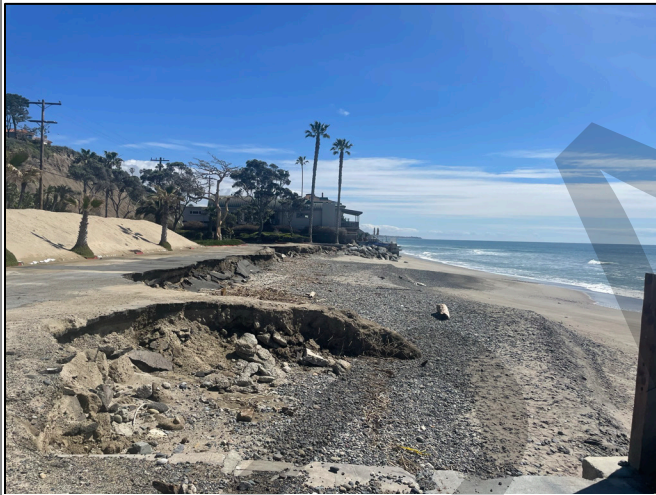
Capistrano Beach Park adjacent to Capistrano Bay District
(Anchor QEA, March 6, 2023)

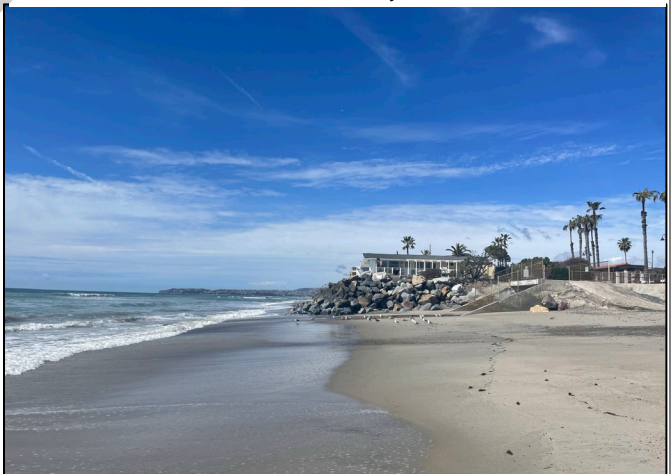
Capistrano Shores from North Beach
(Anchor QEA, March 6, 2023)

The Capistrano Shores 0.7-mile segment is lined with oceanfront homes. These homes face the same beach erosion issues as Capistrano Bay District and some homes are protected by seawalls or rock revetments and are exposed to tide and wave action, which can be large during extreme conditions (Figure 7).

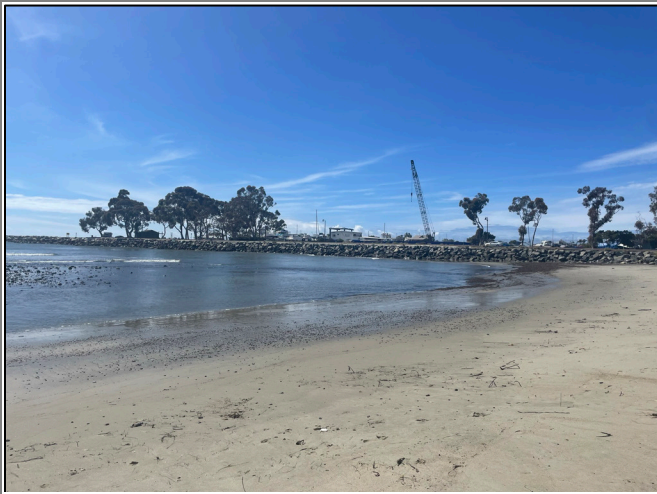
West area beach adjacent to Dana Point Harbor
(Anchor QEA, March 6, 2023)

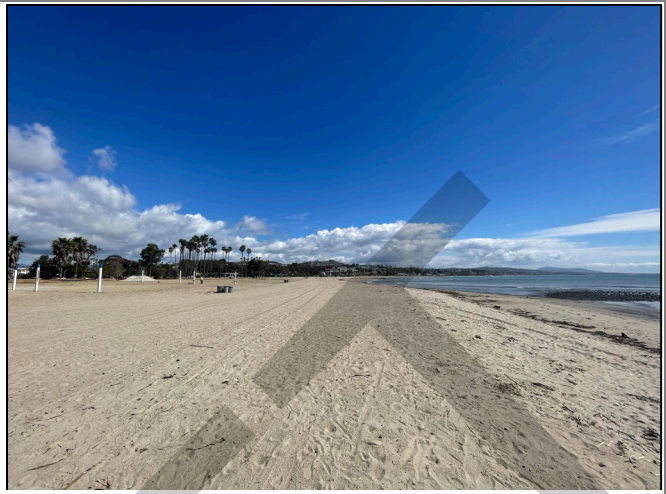
West area beach with cobble in nearshore
(Anchor QEA, March 6, 2023)

The west area of Doheny State Beach has an approximately 1,400-foot-long, relatively wide, stable beach and is fixed by the Dana Point Harbor East Breakwater on the west side, Thor's Hammer rock groin on the east side, and 2-foot retaining wall on the north side. The Thor's Hammer rock groin was constructed along the west side of San Juan Creek to compartmentalize the beach between San Juan Creek and Dana Point Harbor to prevent erosion of the adjacent beach (Figure 6). Typically, from late spring to late fall, a natural beach berm forms across the creek mouth separating the creek and ocean. Large flows from San Juan Creek can and do breach the berm.

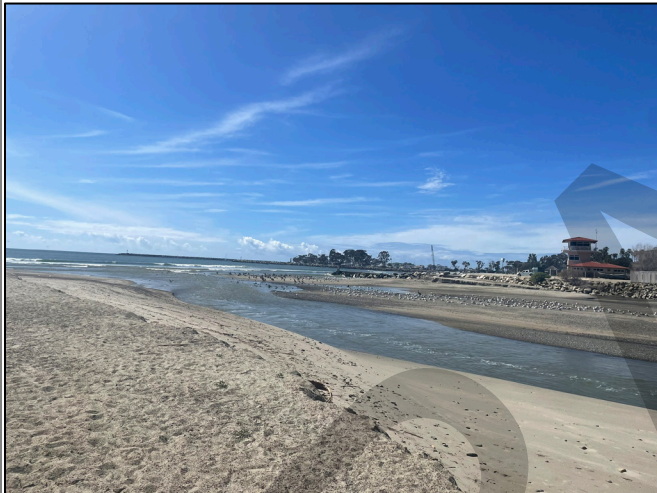
San Juan Creek mouth and Thor's Hammer rock jetty
(Anchor QEA, March 6, 2023)

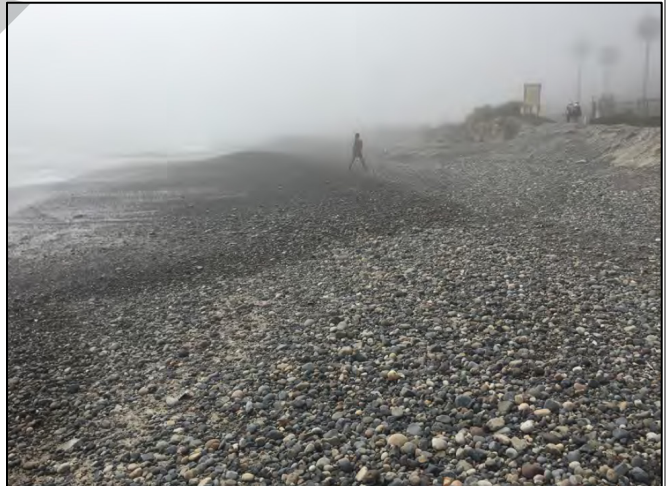
Exposed cobbles June 2020 (OC Parks 2021a)

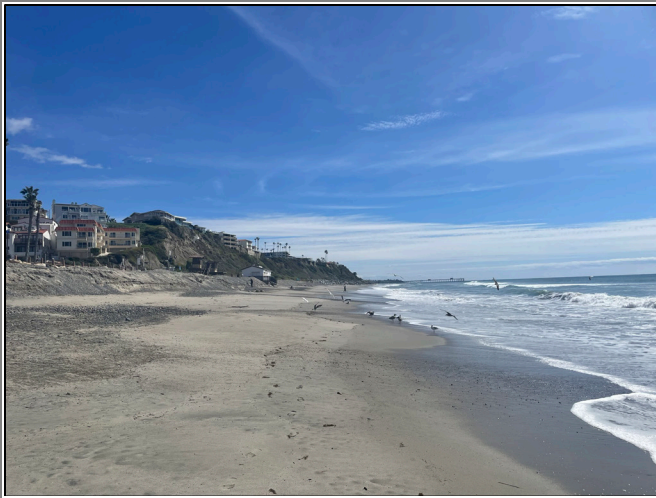
North Beach
(Anchor QEA, March 6, 2023)

San Clemente City Beaches have varying beach widths. Beach width monitoring shows that the overall shoreline is marginally erosive with most of the damage to public facilities occurring from storm conditions (USACE 2012). Variations in the beach width are seen from aerial photographs, with relatively wider beach at inundations along the coastline. In general, relatively wider beaches occur at

North Beach, Linda Lane Park, San Clemente Municipal Pier, T-Street Beach, and Calafia Beach Park. The narrowing of the beach is seen in between North Beach and Linda Lane Park and corresponds to the length of shoreline with riprap protection along the railroad. Storm damage to the railroad riprap protection has typically occurred from ESNO storms in 1998 and 1993. Beach nourishment was conducted as part of the San Clemente Opportunistic Beach Sand Replacement Program, which placed 5,000 cy at North Beach in 2005 and 12,000 cy in 2016 with material trucked from a Santa Ana River sediment clearing operation.

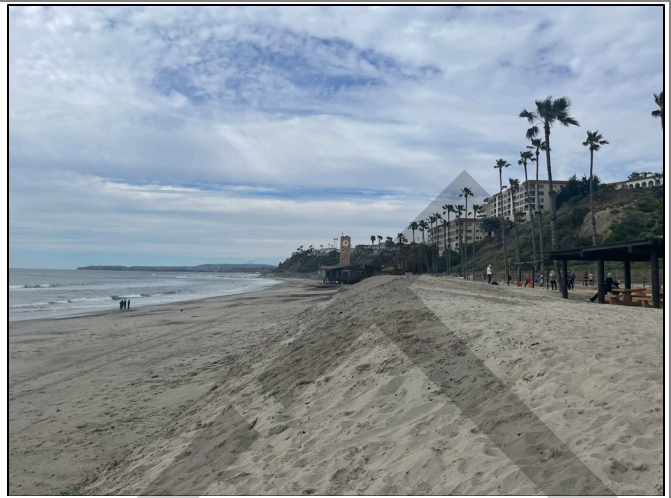
San Clemente City Beach and Marine Safety Building
(Anchor QEA, March 6, 2023)

San Clemente Marine Safety Headquarters and parking lot are located seaward of the railroad near the San Clemente Municipal Pier. Beach access across the railroad is available at Corto Lane, Municipal Pier, and Trafalgar Canyon. The pier was damaged during ENSO storms in March 1983, which was estimated to have had 20 to 25-foot waves, and in 1988. Repair costs for the pier were approximately \$2.1 million for the 1983 storm damage and approximately \$2.3 million for the 1988 storm damage (USACE 2012). Similarly, the Marine Safety Building located on the beach, has experienced damage from large storms resulting in wave overtopping and erosion beneath the building piles. Repairs to the City's Marine Safety Headquarters Building were made in 1986, 2003, and 2020, and the City is currently evaluating options for facility upgrades in place as well as in a location landward of the railroad.

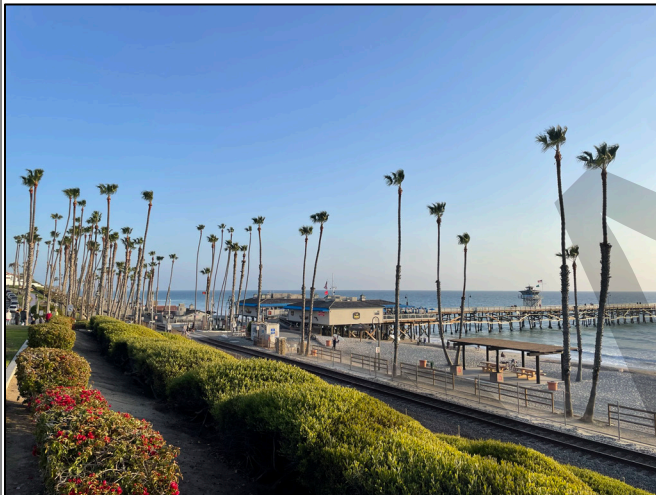
San Clemente Municipal Pier
(Anchor QEA, March 6, 2023)

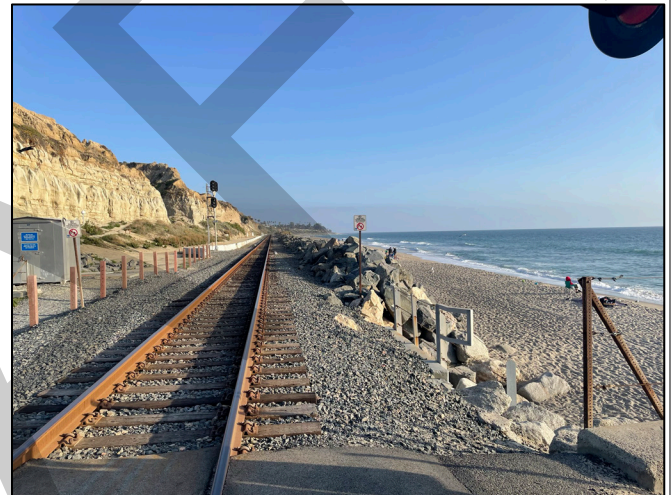
LOSSAN Railroad with riprap
(Anchor QEA, March 6, 2023)

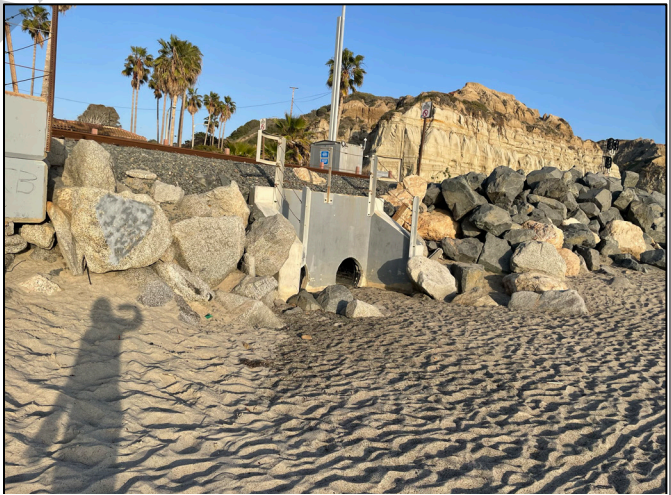
Stormwater infrastructure at Califa Beach Park
(Anchor QEA, March 10, 2022)
